Fwd: #294 Parker Pond Dam - Inspection 4/22/17 - Hazard & Condition Assessment

Hazard and Condition Assessment of Parker Pond Dam

Inspection Date – 4/21/17

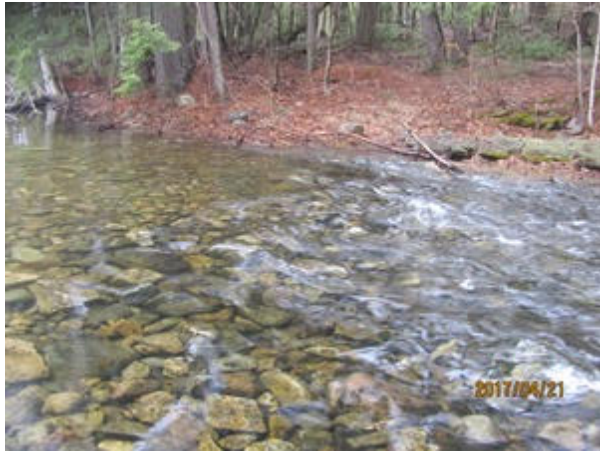
1. Spillway. Flow 12 cfs.

1. Scour

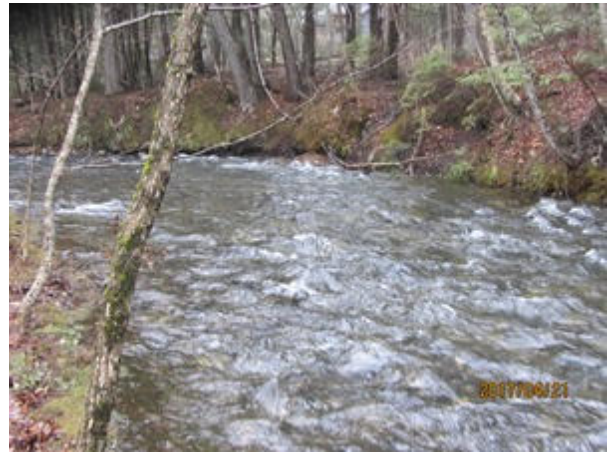
The most serious defect is the undercutting of the left bank of the spillway which is causing one mature pine tree to lean. This tree will eventually fall into the spillway channel and impede flow. At the top of the dam is some local settlement and at the toe the old stones has moved.

2. Downstream Spillway Channel.

1. Scour undercutting bank

2. Leaning Tree

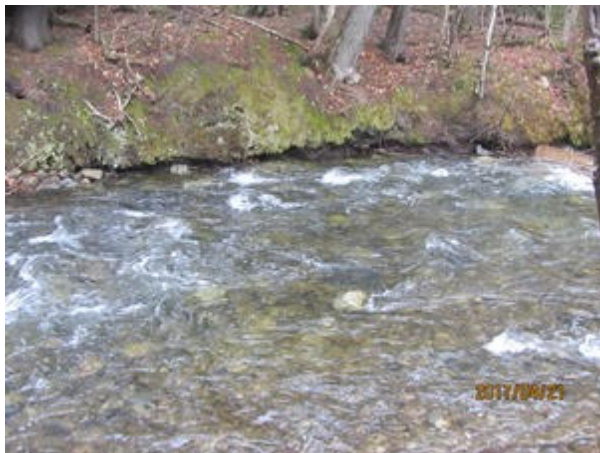
3.1) Routing a 100 year storm under antecedent moisture condition of 3, it was calculated that the lake would rise 2' above normal pool and peak at 250 cfs and the estimated water velocities in the spillway will approach 4.5 fps. This velocity could dislodge smaller stones in the riverbed, especially downstream where it is anticipated the velocity will increase. This flow is likely to further damage the left bank of the spillway especially where it is currently damaged.

3. Channel erosion undercutting left abutment

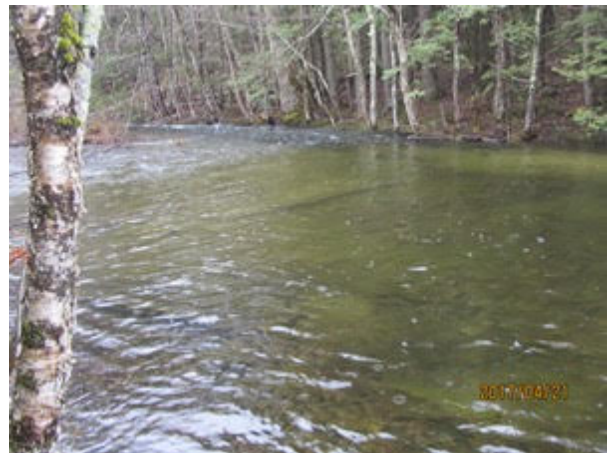
4. Tail pond / spillway channel junction

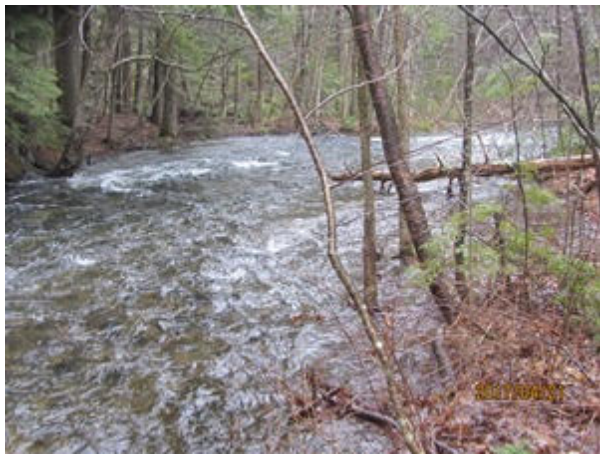
5. Downstream spillway channel – No erosion

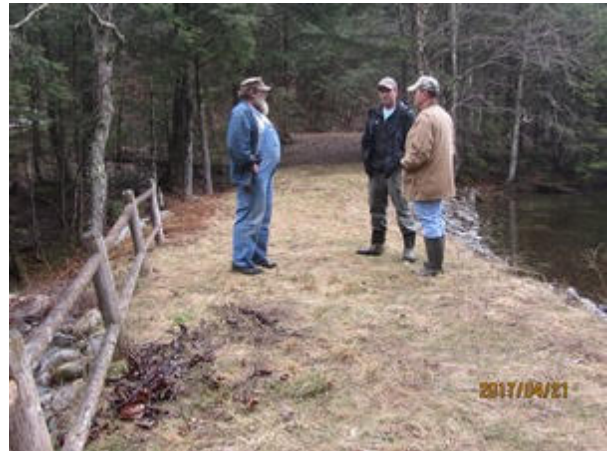
3. Settlement

6. Top of dam right – Settlement

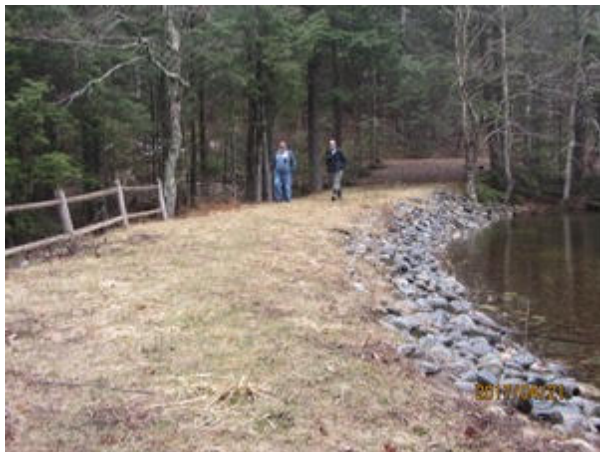
7. Embankment R – Top even - Rip-Rap in place

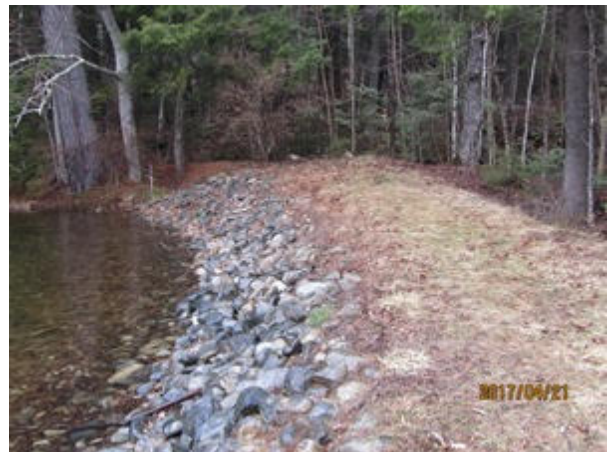
8. Embankment L – Top even - Rip-Rap in place

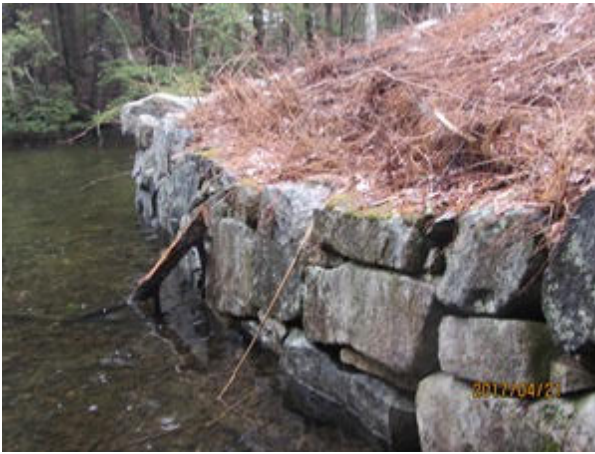
9. Toe L – No erosion or visible movement

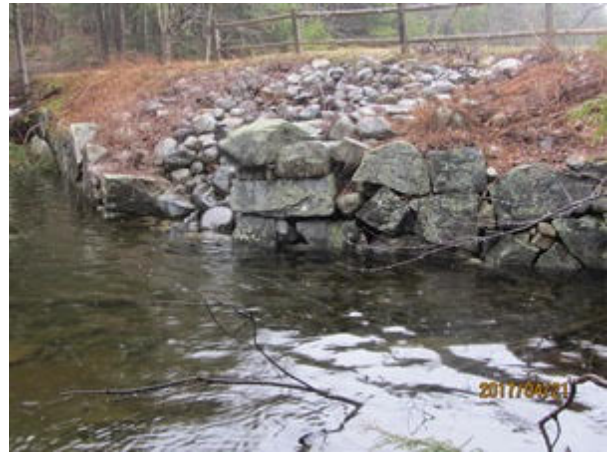
10. Filled-in gateway – insignificant settlement

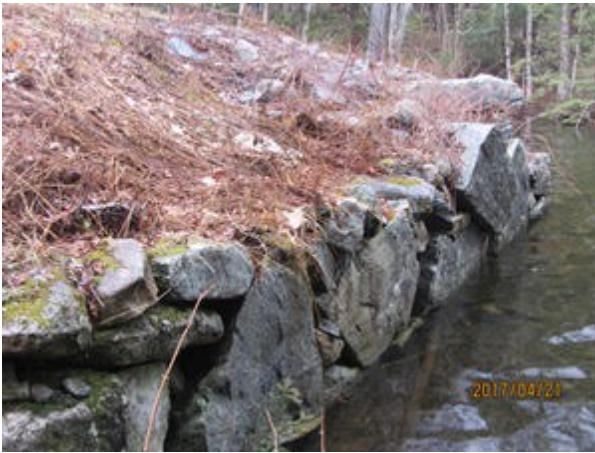
4. Stone Movement

11. Toe right. Stone displacement

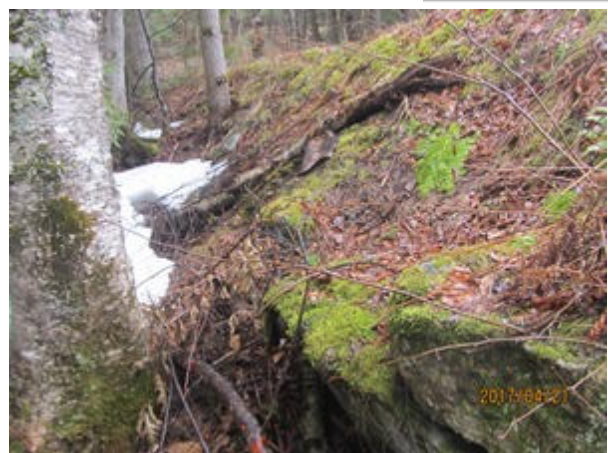
5. Stone Rotation

12. Toe right – Stone rotation downstream

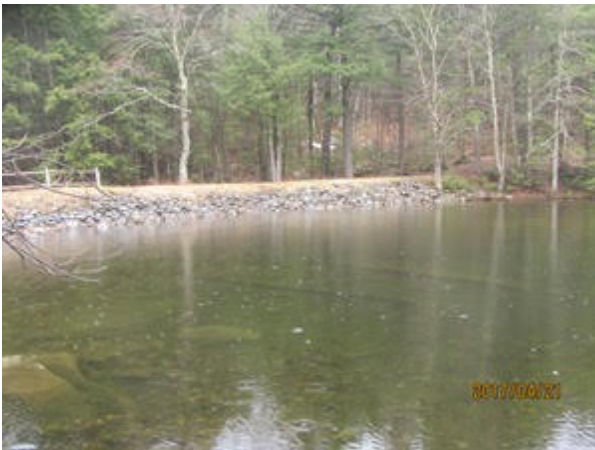
13. Dam right – logs underwater

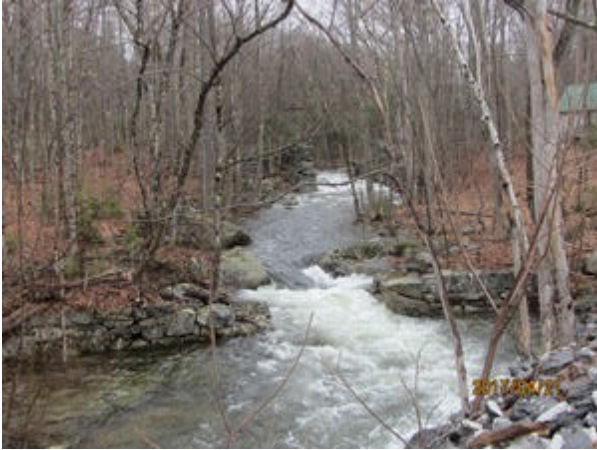
15. Downstream river approaching Bridge #2987

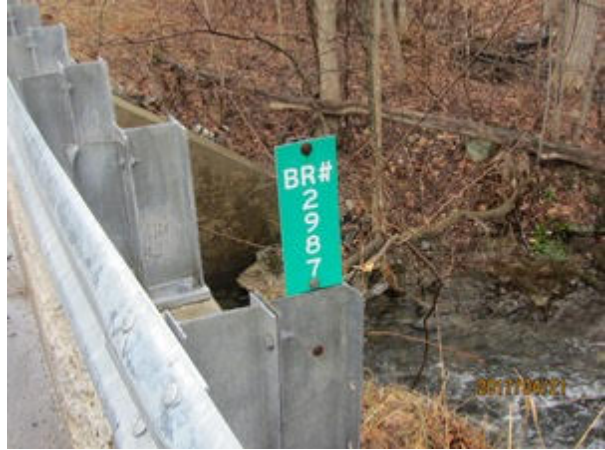
16. Bridge #

3.4) The first structure downstream of the dam is Bridge #BR 2987. During the breach flow in 3) above, R41 will overtop an estimated 1.4' in the area shown in photo 16. 3.5) The bridge itself will not overtop during the FWB because it is not the low-point in the road.

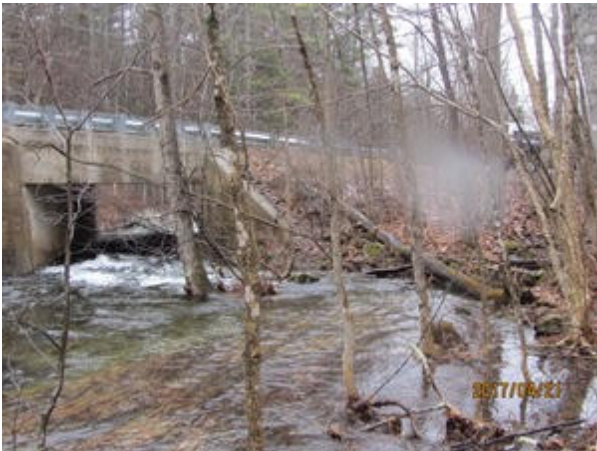
17. BR# 2987 – Small culvert likely

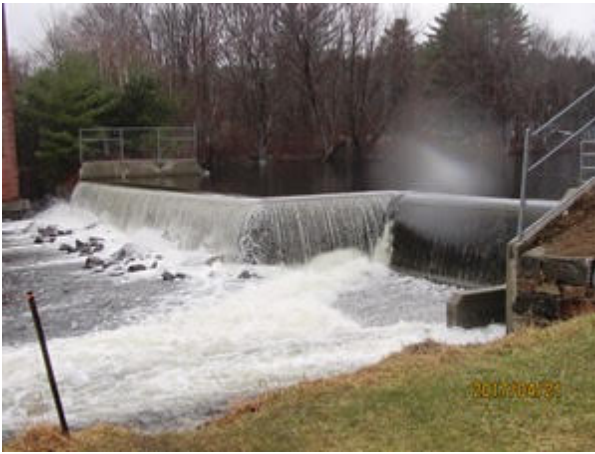
3.6) A FWB of Parker Pond dam will increase the flow at Taylor Pond Dam, and the R41 bridge immediately downstream, by 1,165 cfs. This incremental flow will not will not overtop either the dam or the bridge during normal conditions. However, if the same breach occurred during a 100 year storm, Taylor Pond and the bridge on R41 may overtop. Thus both of these structure should be placed under observation during an emergency.

18. Taylor Pond Dam
